THE BAHAMAS POST HURRICANE DORIAN RECONSTRUCTION

INFRASTRUCTURE

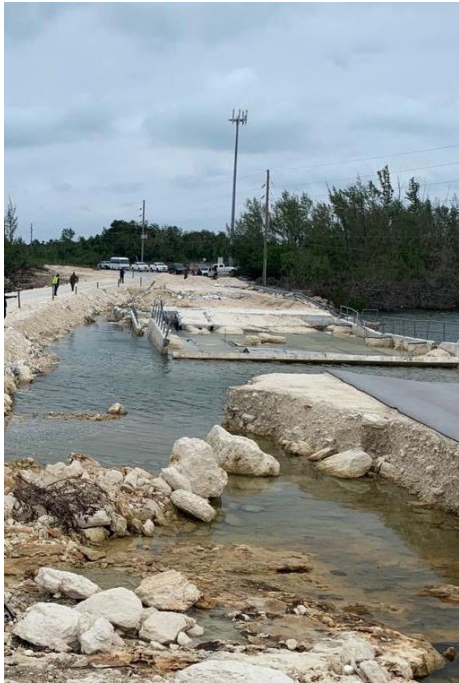
The **Little Abaco Causeway** was built in the 1960's to connect Little Abaco Island to Great Abaco Island. Construction of the causeway effectively cut off the migration route for marine life to the south side of the islands which has shallow waters and vast mangroves ideal for spawning. Additionally, it prevented access to small boat traffic through the underlying channel. In 2016, a culvert system was constructed to allow for the water flow under the road. During the passage of Hurricane Dorian, the culvert structure suffered severe damage from storm surge. Consequently, it has been recommended that a bridge be constructed to replace the causeway.

PROJECT 1: LITTLE ABACO BRIDGE

- Remove existing culvert boxes and set aside for inspection and reuse at another less vulnerable site.
- Construction of new road bridge with a total length of 270 feet and a width of 25 feet (20 foot road carriage with 5 feet verge/sidewalk to road edge).
- Substructure - Bridge to be supported on sheet piled abutments with rock revetment protection. Provide parapets to wing walls.
- Superstructure - steel truss.
- Environmental Assessment - one of the main advantages of the project is it will restore the original environment by re-opening the channel there will clearly be a net environmental benefit to the project. It is felt that this aspect could be adequately addressed by an environmental management plan incorporated into the contract documents.
- Road improvements in the vicinity of the bridge.
